EWPP Power Failure Analysis

City of Houston

Project No. 153662

February 17, 2023

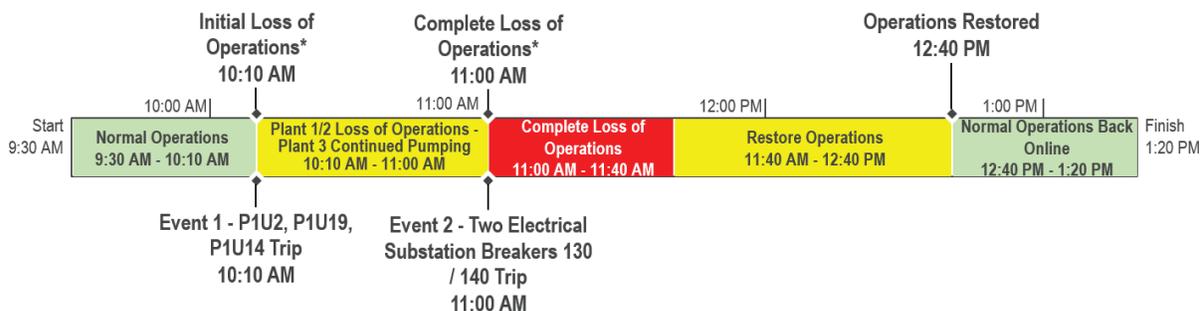
Figure 1: Timeline of events from November 27, 2022
